# TT418: DTCs P2135 and P2101 Theory and Diagnostics

November 3, 2009

APPLIES TO	SYMPTOMS
2008-Later Touring, Police and Trike Models	<ul style="list-style-type: none"><li>• Driveability or Performance Concerns</li><li>• Abnormal or Erratic Mechanical Operation</li><li>• Intermittent or Erratic Electrical Operation</li></ul>

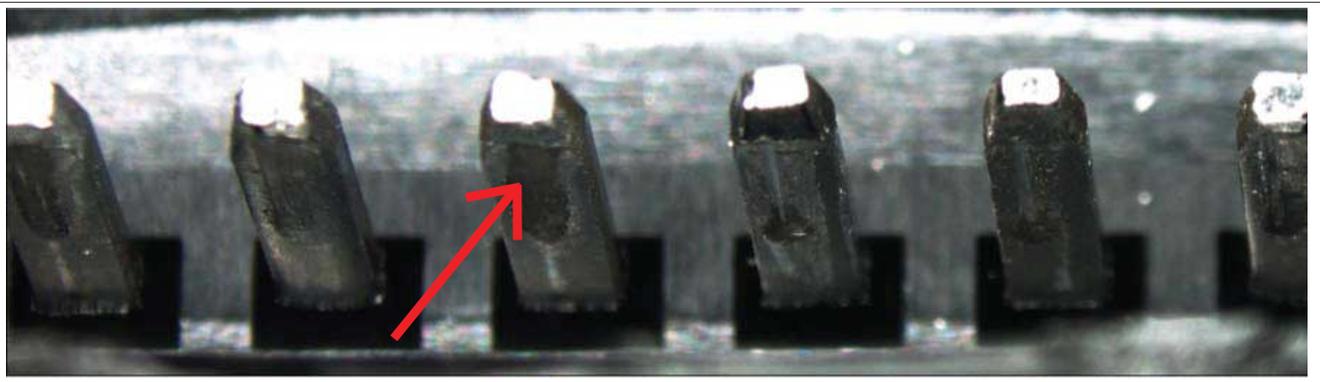
It is believed that fretting corrosion is a major contributor to this code. A poor connection at the TCA can affect the sensor voltages reported to the ECM and set the DTC. As you can see from the General Information section, the sensor voltage only needs to be altered by 0.13 VDC to possibly set the code.

The most common vehicles to have these symptoms are those with more than 8000 miles or those vehicles with 103ci and larger engines. The vibration that these connections are exposed to is believed to contribute to the fretting condition.

**Figure 2. View of Fretting on Pins**

1. While monitoring the TPS 1 and TPS 2 voltage on the DT II, wiggle the TCA and the ECM connectors.
2. If you the voltage changes while moving the ECM connector, inspect/replace the affected ECM terminals (Part No. 72605-08). These wires are: TPS1, BN/V pin 37 of the ECM, and TPS 2, BN/R pin 36 of the ECM.
3. If no voltage change is noted while moving the ECM connector, the connection issue could be in the TCA. Replace pins 1, 4, 5 and 6 at the TCA connector 211B (Part No. 72168-07).
4. Before connecting the TCA connector, clean the male TCA pins with a swab and alcohol, then assemble with dielectric grease (Part No. 99861-02 - Nyogel 760G).
