# TT418: DTCs P2135 and P2101 Theory and Diagnostics

November 3, 2009

APPLIES TO	SYMPTOMS
2008-Later Touring, Police and Trike Models	<ul style="list-style-type: none"><li>• Driveability or Performance Concerns</li><li>• Abnormal or Erratic Mechanical Operation</li><li>• Intermittent or Erratic Electrical Operation</li></ul>

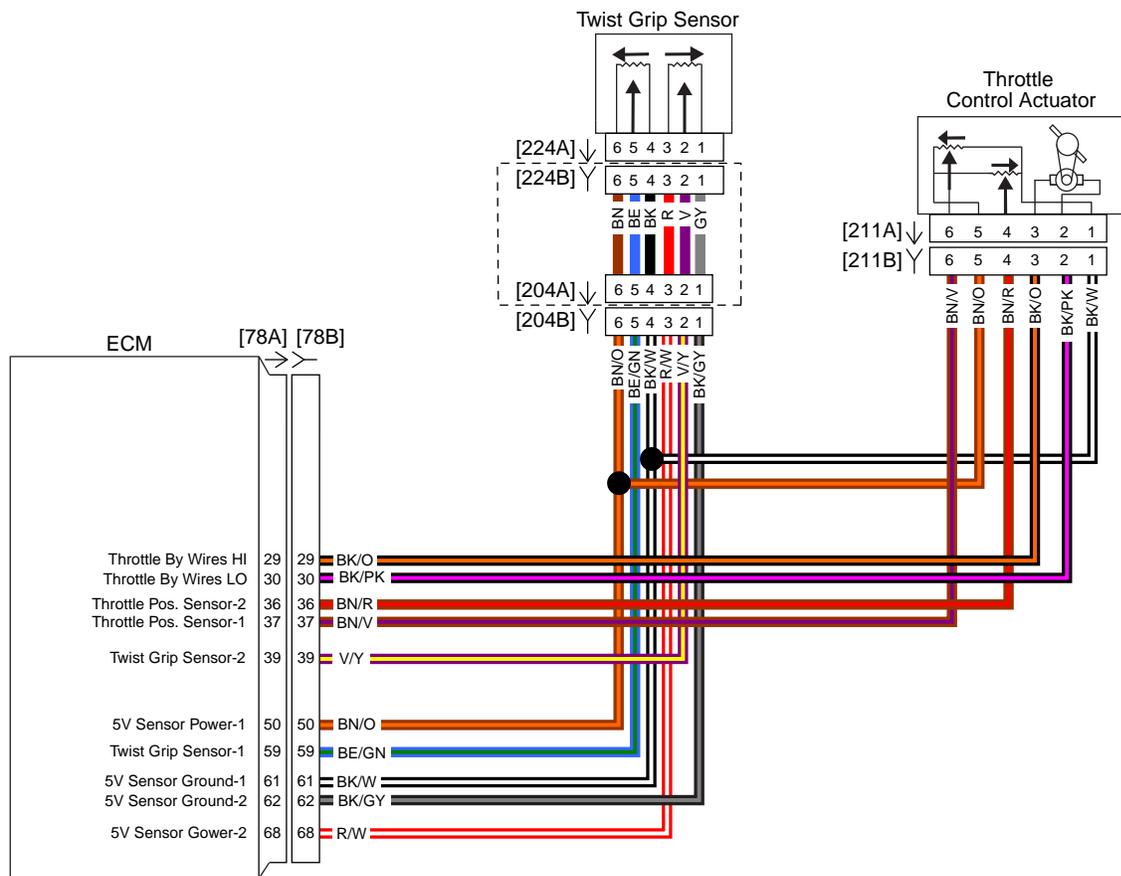
**Figure 1. Schematic**

The two TP sensors work opposite of each other. As the throttle plate opens, TPS1 voltage ranges from 0.0-5.0V, while TPS2 voltage ranges from 5.0-0.0V. The sum of the two TPS voltages should always measure approximately 5.0V. These wires are: TPS1, BN/V pin 37 of the ECM, and TPS BN/R pin 36 of the ECM.

The TP sensors 1 and 2 should never add to more than 5.13 VDC or less than 4.87 VDC. A sum of voltages out of this range should register a current P2135 code.
